Elevator Incident Investigation Crockett Hotel, San Antonio

Location: Crockett Hotel 320 Bonham Street, San Antonio, TX 78205

ELBI: 3325 **Decal:** 010070

Date of Incident: December 28, 2011

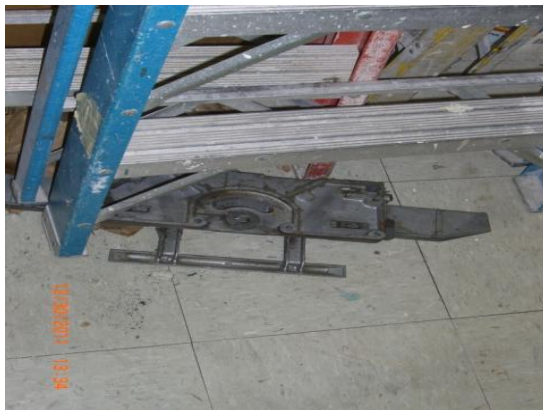
Crockett Hotel-010070

Used door clutch on 7th floor adjacent to elevator

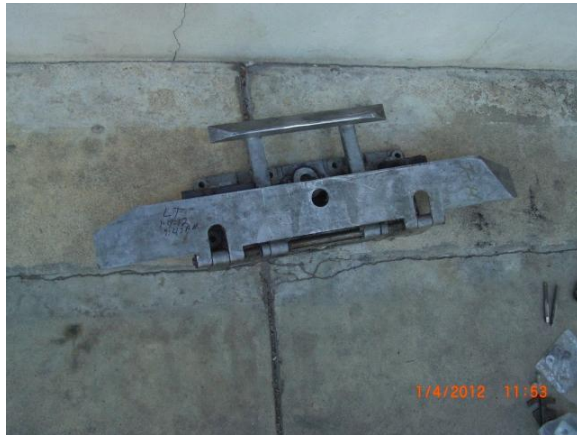
Crockett Hotel-010070

Used car door clutch found on 7th floor next to elevator

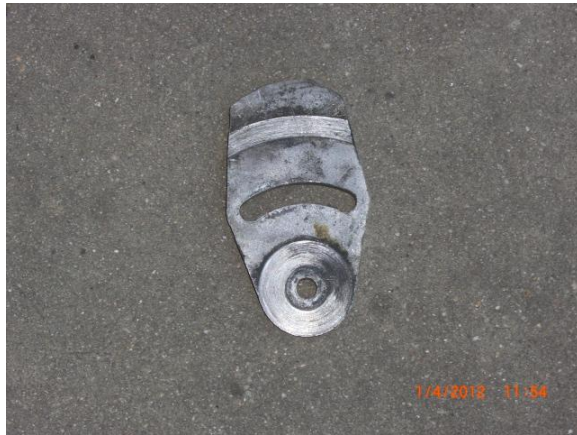
Crockett Hotel-010070

Piece of old door clutch link found on 7th floor next to elevator

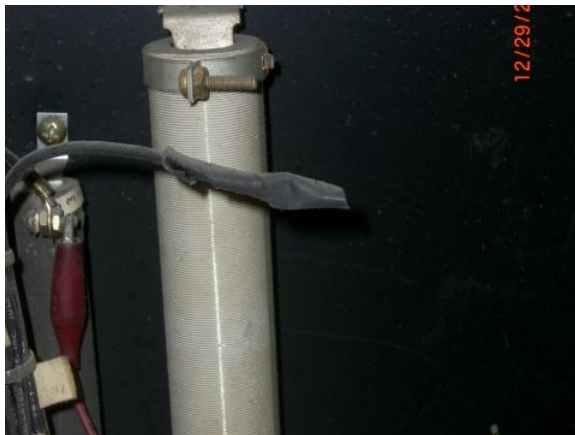
Crockett Hotel-010070

A preponderance of the evidence indicates that someone (who exactly, is unknown) knew that something was wrong with the drive machine brake as evidenced by the jumper seen upon the brake resistor. The placement of that jumper took an intentional and deliberate act and would only have been undertaken in response to some noted abnormality by someone with unique knowledge of the elevator equipment controls. How long the jumper was in place prior to the incident and the investigation cannot be determined. The installation of the jumper is a violation of both the elevator code and the posted instructions pasted onto the elevator controller swing panel by the maintenance contractor. See below:

In this case, the use of jumpers indicates a failed attempt to treat the symptoms of brake trouble when the disease was the fact that the brake itself was not installed, adjusted and maintained as prescribed by the manufacturer. It was found that the manufacturer's brake replacement and adjustment instructions were not readily available for their employees to use. Even when installing new replacement brakes, they had no instructions and were deliberating amongst themselves how to go about properly adjusting the brake. The undeniable fact is that the old brake was capable of being adjusted properly and appeared to function correctly after being properly adjusted.

Jumper left in controller on resistor and resistor bypassed

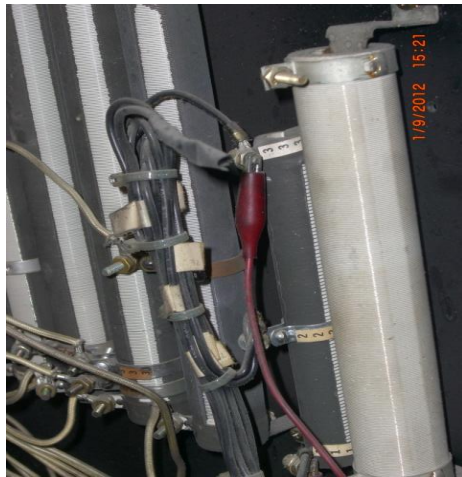
Crockett Hotel-010070

At this point the voltage across the brake coil was measured and found to be 108 VDC. After removing the jumper that bypassed the series brake resistor "B" the voltage was found to be 104 VDC. As previously noted the brake parallel resistor "B1" was bypassed by having had its top wire relocated to the bottom terminal effectively removing it from the circuit. A photo of that circuit is below. The red jumper was on series resistor "B" and the wire on the 177 side of parallel resistor "B1" was moved to electrically be located on the 178 terminal side of that resistor. The effects of these actions were to:

1. Remove series resistor B from the circuit thus increasing the voltage across the brake coil B
2. Eliminate the effect of parallel resistor B1 in dissipating the current created by the collapse of the magnetic field across the inductor (brake coil) when the applied voltage is removed

Jumper left on controller on resistor and resistor
bypassed

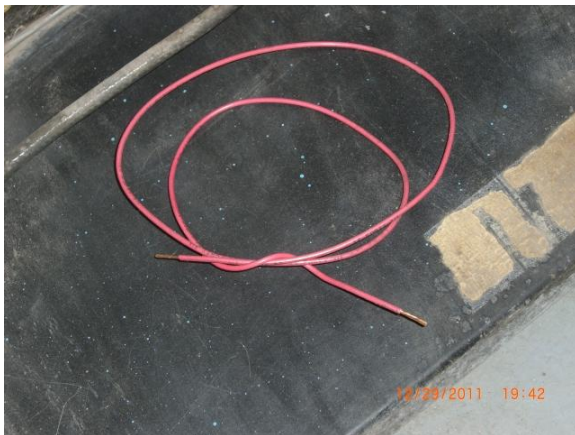
Crockett Hotel-010070
Temporary jumper left laying in bottom of
controller

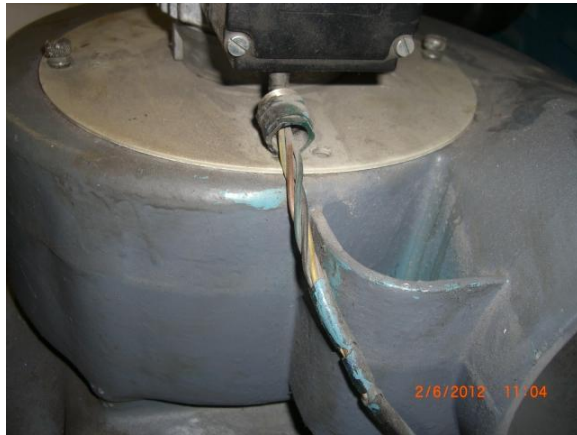
Crockett Hotel-010070

8. Failed to maintain the equipment by allowing oil and grease to accumulate on the machine room floor [74.60(a)] and [74.60(e)(5)]
9. Failed to safely maintain the equipment by allowing flexible metal conduit to become electrically and mechanically non-continuous at the drive machine brake and several locations on the car top [74.60(a)] and [74.60(e)(5)]

Exposed conductors going to the drive motor
tachometer device

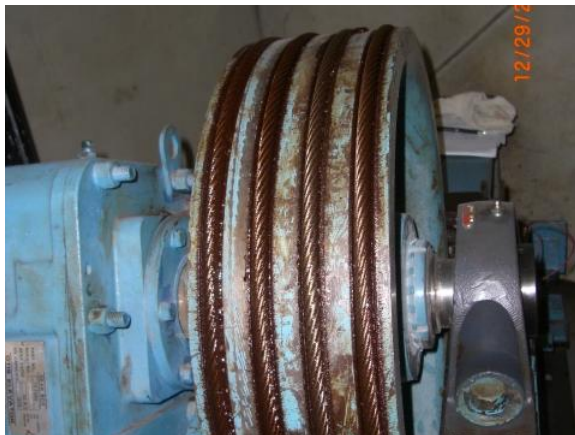
Crockett Hotel-010070

Drive sheave and ropes showing excessive
lubrication

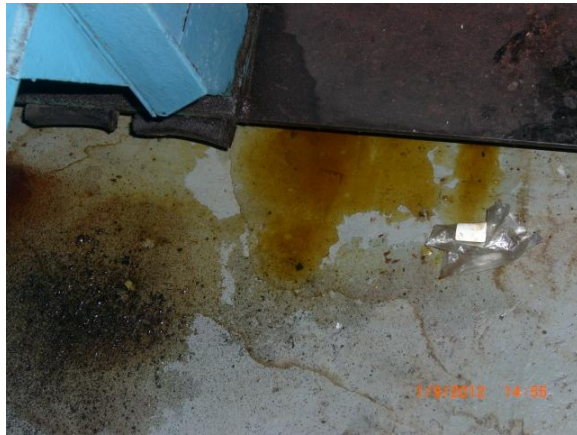
Crockett Hotel-010070

Oil and debris on machine room floor

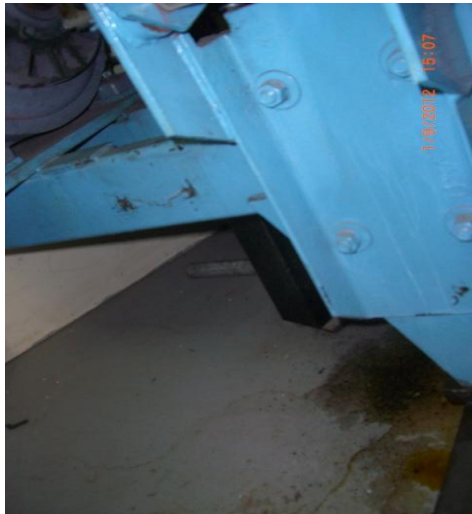
Crockett Hotel-010070

Oil on machine room floor

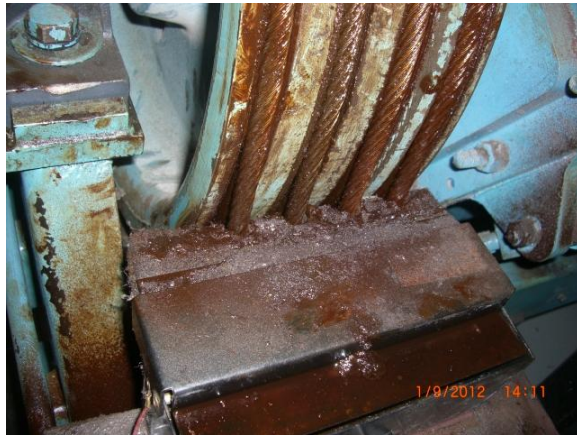
Crockett Hotel-010070

3. The grease coating the ropes makes an adequate inspection of the ropes difficult if not impossible. (ASME A17.1-2007-8.6.4.1.1 and 8.6.4.1.2)
4. The interlock at the 7th floor is missing its cover.

Suspension ropes with excessive grease and visible rouging

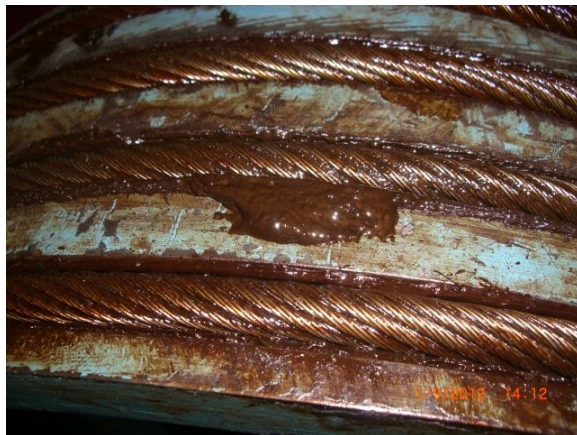
Crockett Hotel-010070

Suspension ropes with excessive lubrication

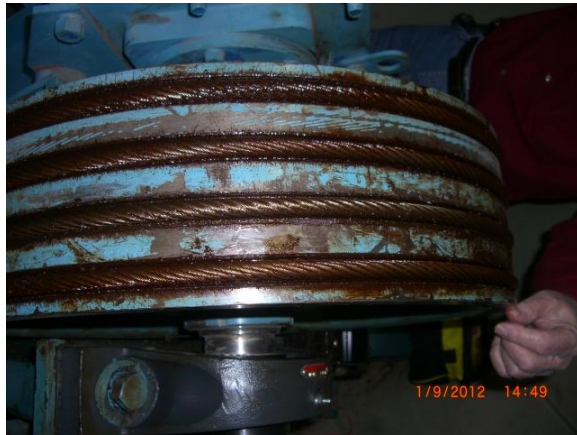
Crockett Hotel-010070

Suspension ropes with excessive lubrication

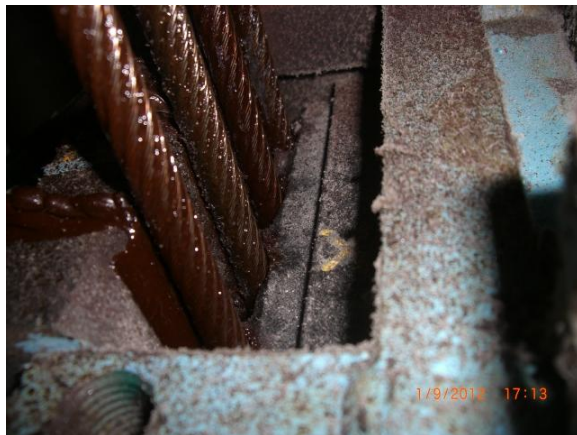
Crockett Hotel-010070

Suspension ropes showing excessive lubrication
and signs of rouging

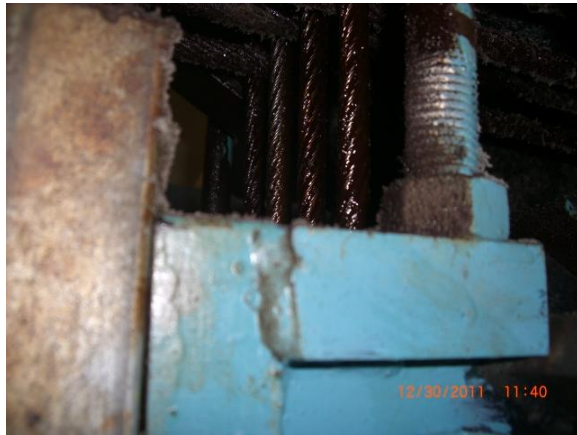
Crockett Hotel-010070

Suspension ropes covered with grease

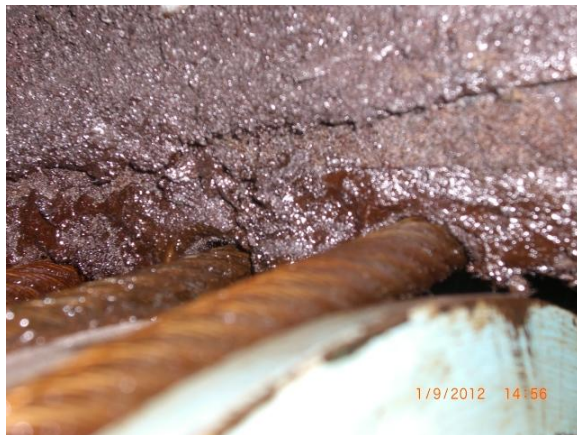
Crockett Hotel-010070

Suspension ropes showing signs of rouging

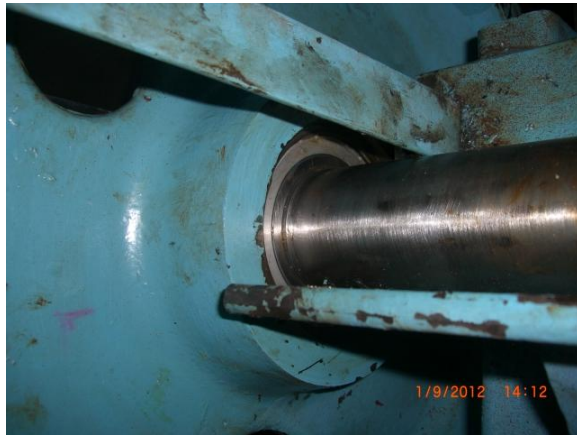
Crockett Hotel-010070
New deflector sheave bearings

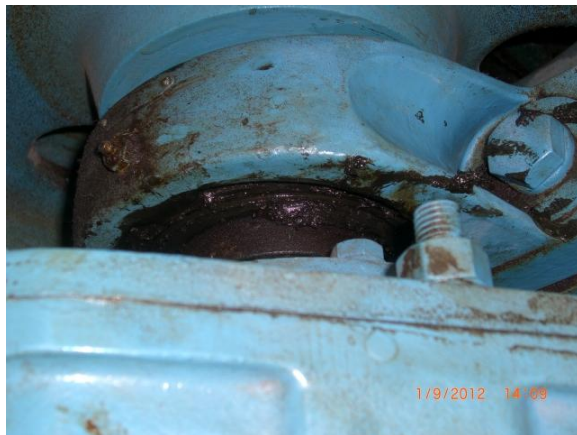
Crockett Hotel-010070
Inboard drive sheave bearing showing excessive
lubrication

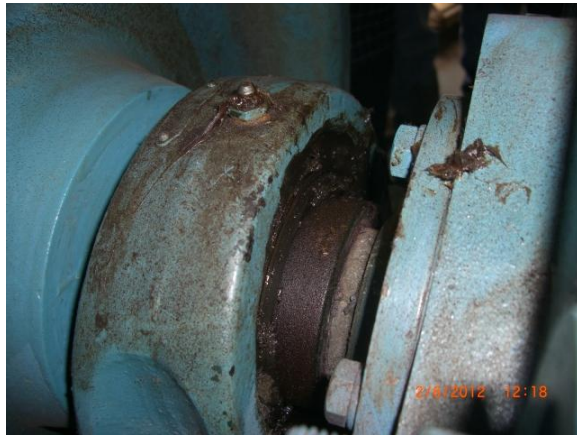
Inboard drive machine bearing showing signs of excessive lubrication

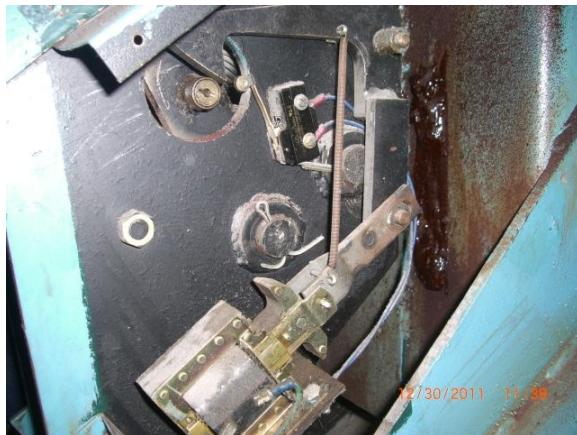
The car was found by the Department on December 29 and 30, 2011, to be above the top floor, the governor switch tripped and the rope brake activated. The motor coupling was broken and most likely broken as a result of the shock of the car counterweight striking the counterweight buffer in the pit. Since that was the case, it is concluded that Ms. Rodriguez must have entered the hoistway below the top landing.

Tripped rope brake

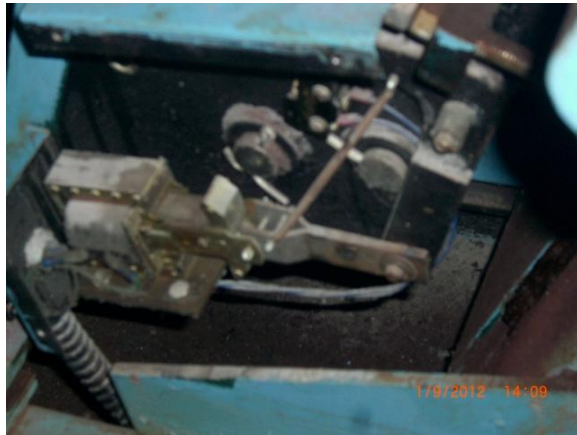
Crockett Hotel-010070
Tripped rope brake

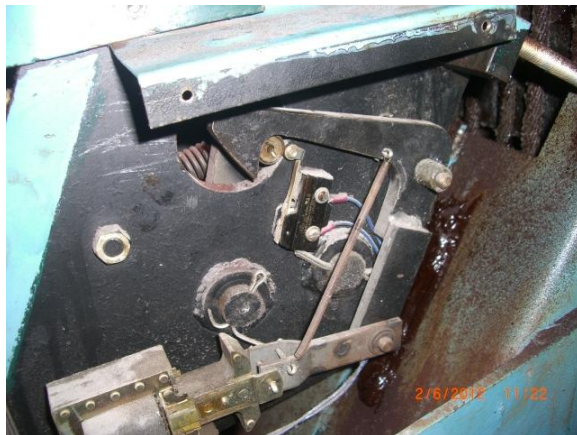
Crockett Hotel-010070
Rope brake not tripped

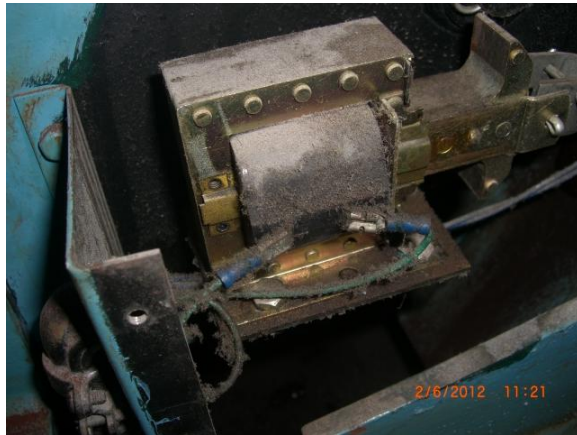
Crockett Hotel-010070
Rope brake coil

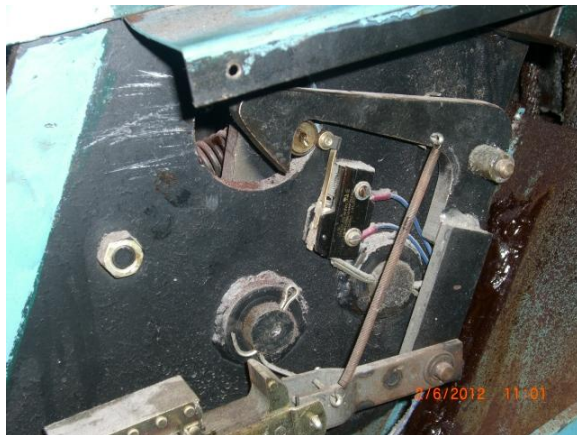
Crockett Hotel-010070
Rope brake not tripped

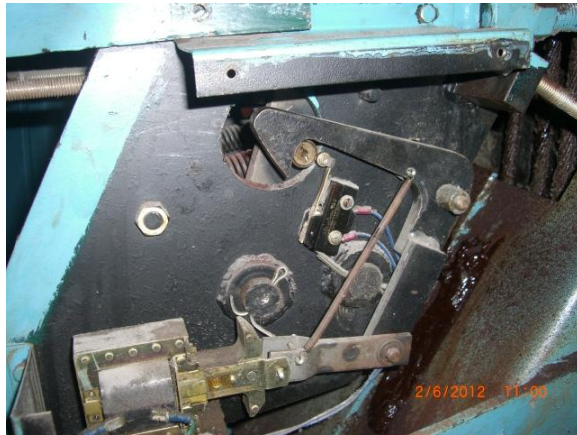
Crockett Hotel-010070
Rope brake not tripped

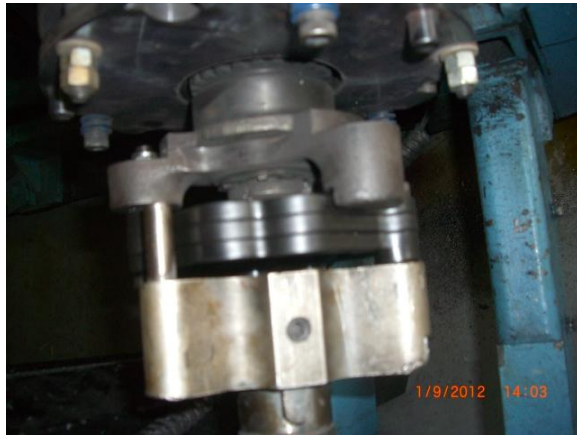
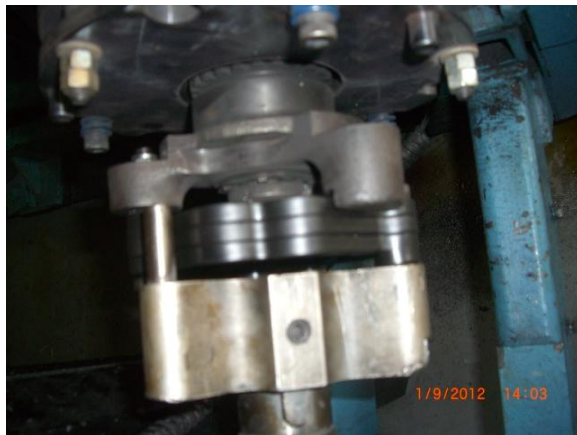
Crockett Hotel-010070
Newly installed coupling disks

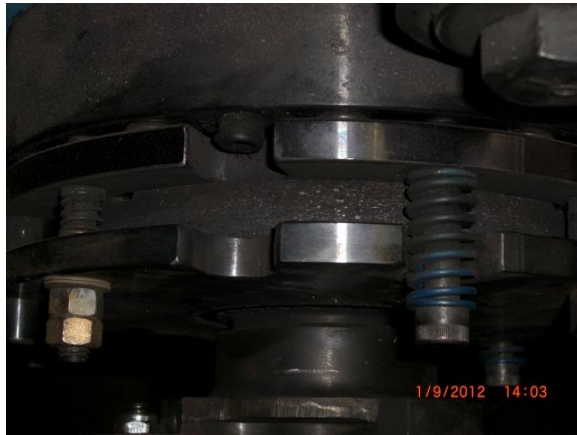
The results of the Department's investigation indicate that the most likely cause of this incident was the uncontrolled movement of the car away from the landing, due to an improperly installed and maintained drive machine brake, after the car and hoistway doors were opened. The most likely scenario is that Ms. Rodriguez placed a down hall call at the 6th floor and waited for the car to arrive. When the car arrived, it slowed down electrically and power opened the doors and subsequently moved away from the floor (in the up direction) in an uncontrolled manner due to the brake not holding the car, leaving the doors open and hoistway opening unprotected. Somehow, even as the hoistway door was attempting to self close due to the absence of the car at the landing, Ms. Rodriguez entered the unprotected opening and fell down the hoistway to her death.

Crockett Hotel-010070
Old drive machine brake

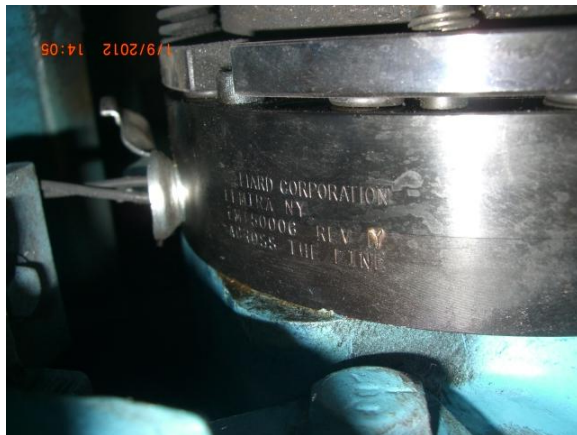
Old drive machine brake and exposed conductors

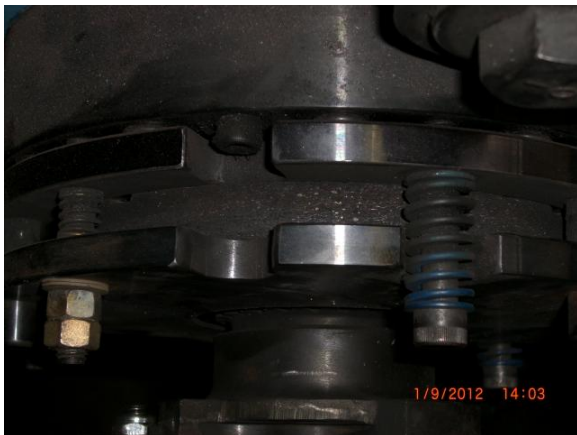
Old drive machine brake

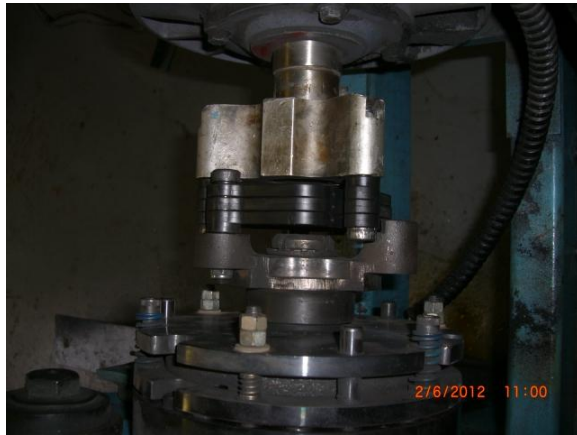
Old drive machine brake with new motor coupling disks

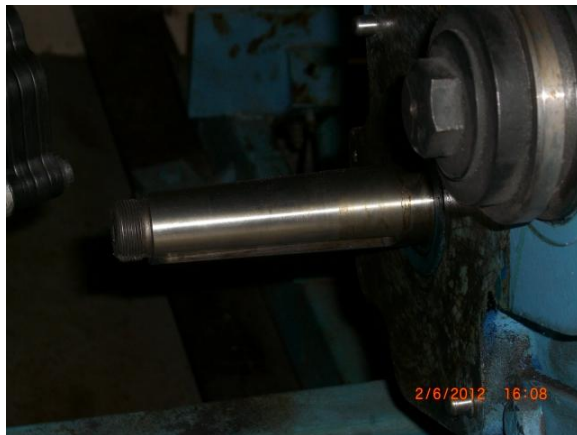
Drive machine input shaft with motor coupling and brake removed

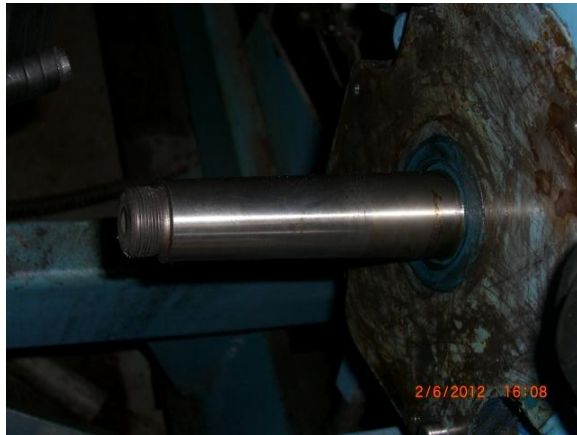
Drive machine input shaft with motor coupling and
brake removed

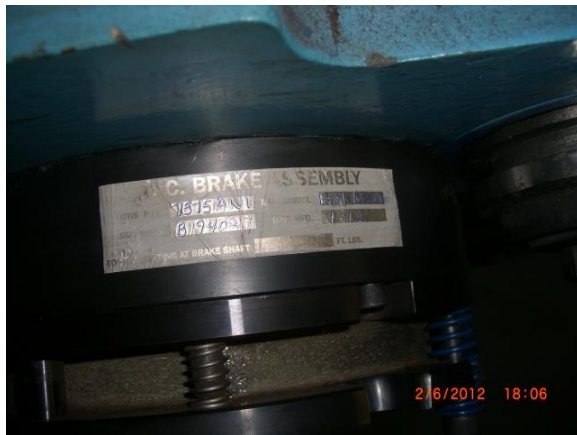
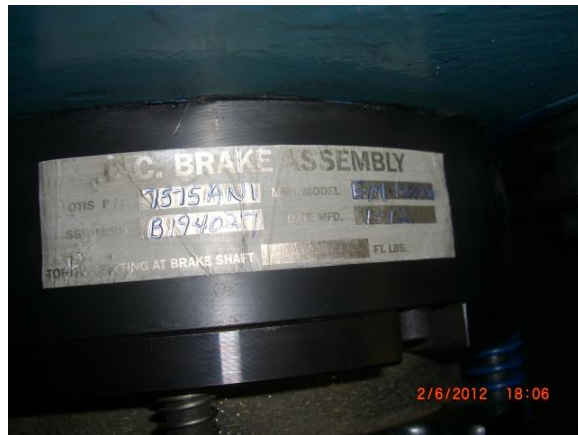
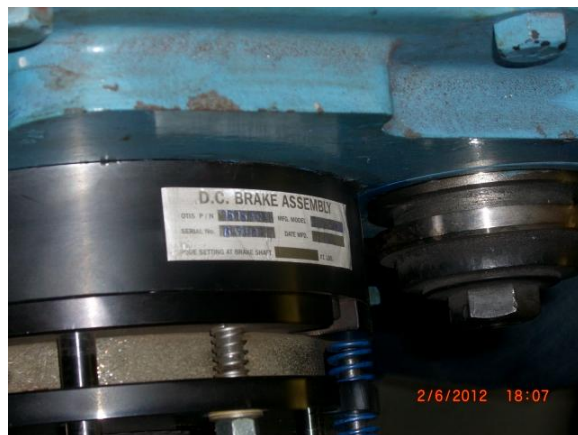
New drive machine brake

14. Failed to safely maintain the equipment by replacing the drive machine brake without verifying the holding capacity of the brake [74.60(a)] and [74.60(e)(5)]

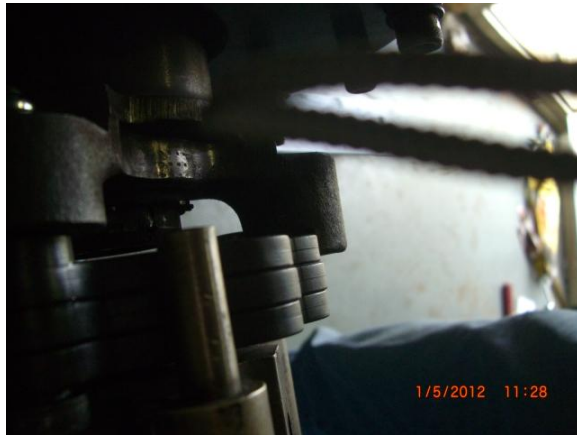
Crockett Hotel-010070
New coupling disks

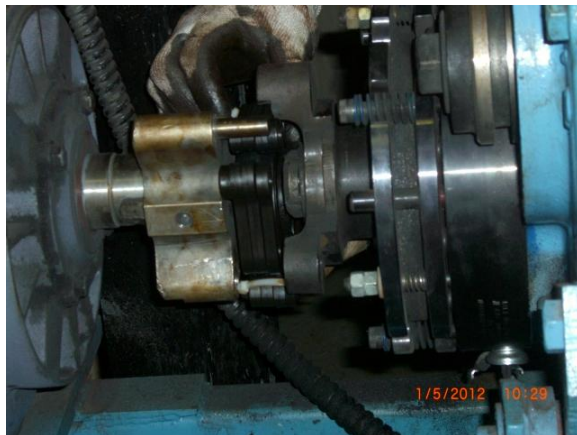
Crockett Hotel-010070
Motor and machine with new coupling disks

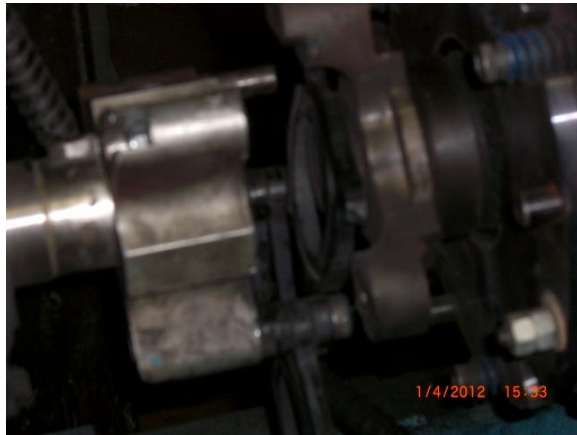
Motor and machine couplings without coupling disks

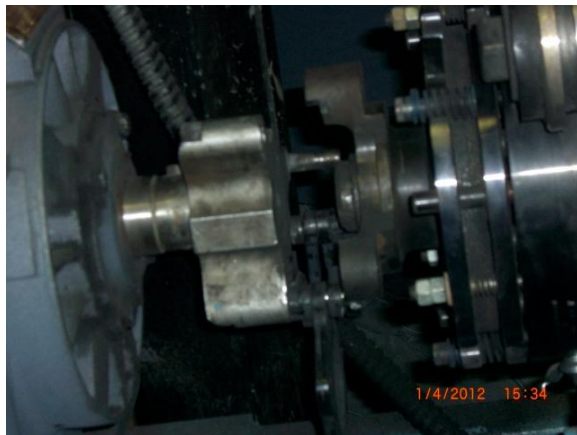
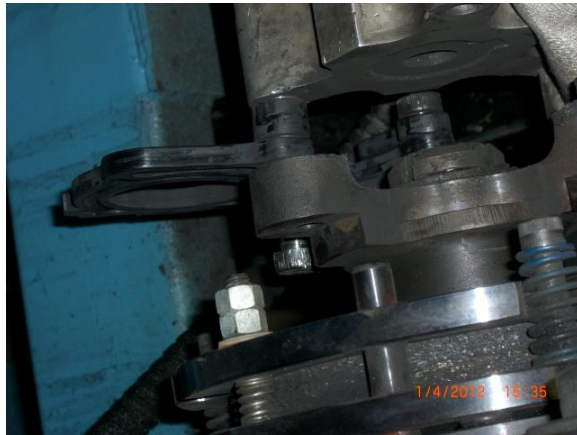
New coupling disks being installed

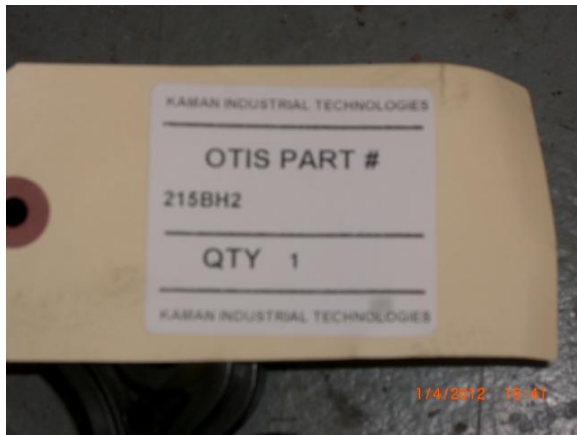
Crockett Hotel-010070
Parts tag from coupling disks

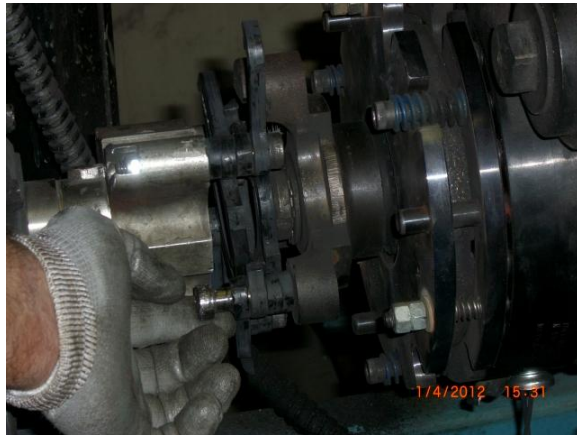
Removal of coupling disks underway

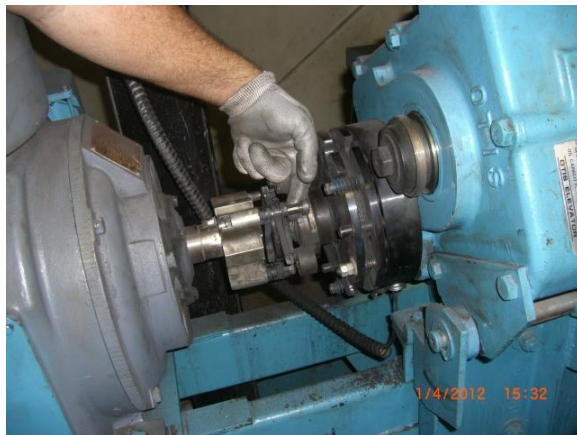
Removal of broken coupling disks underway

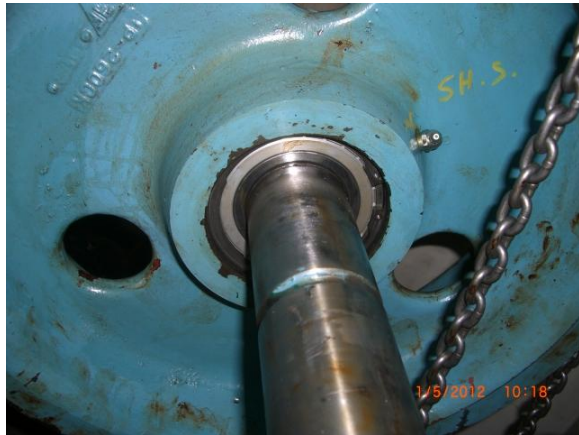
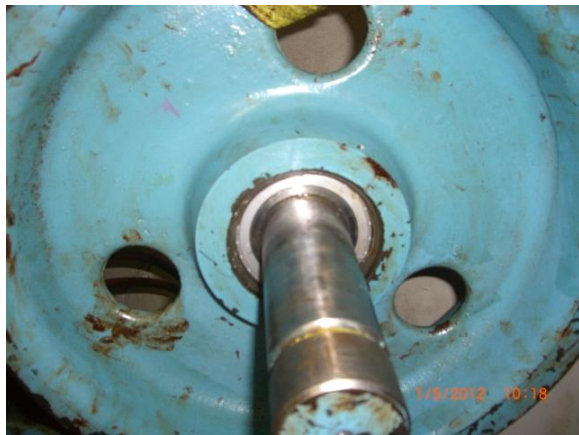
Crockett Hotel-010070
Deflector sheave with new bearings

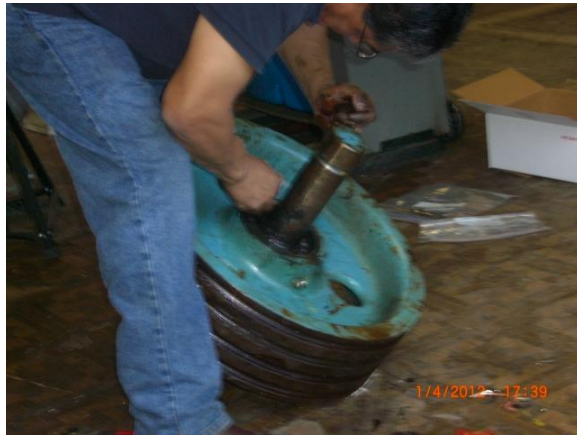
Crockett Hotel-010070
Deflector sheave under repair

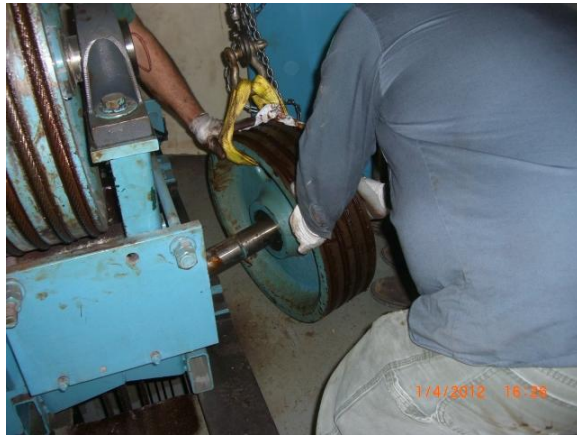
Deflector sheave being removed from machine room

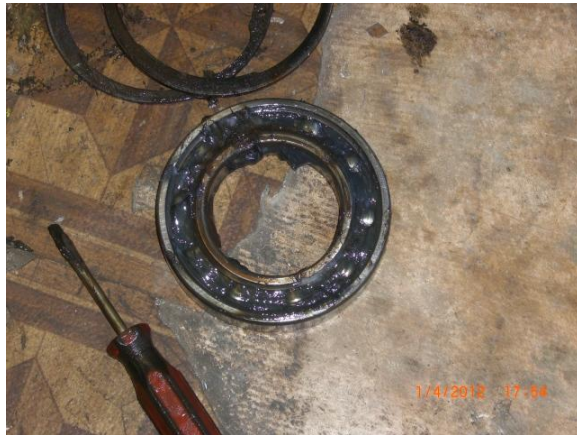
Crockett Hotel-010070
Old deflector sheave bearing

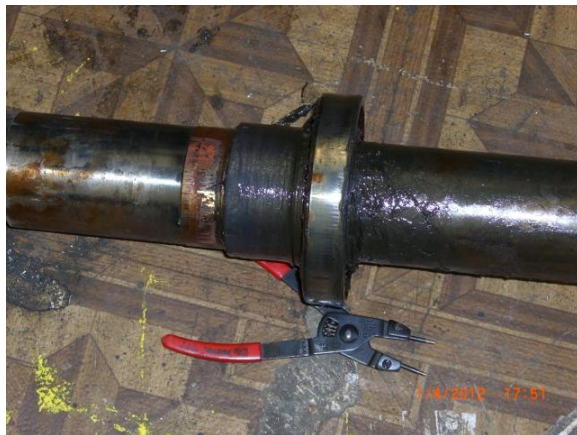
Crockett Hotel-010070
Deflector sheave shaft with one bearing removed

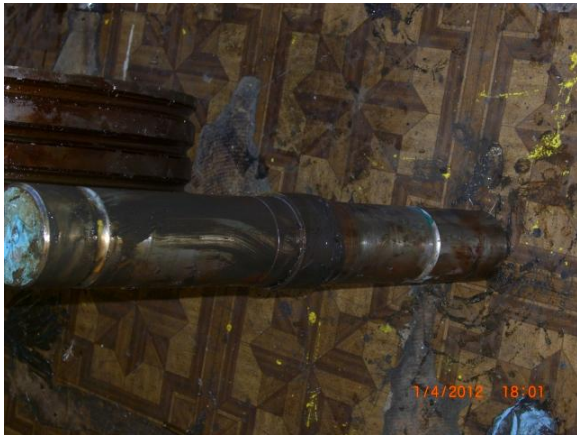
Crockett Hotel-010070
Deflector sheave shaft without bearings

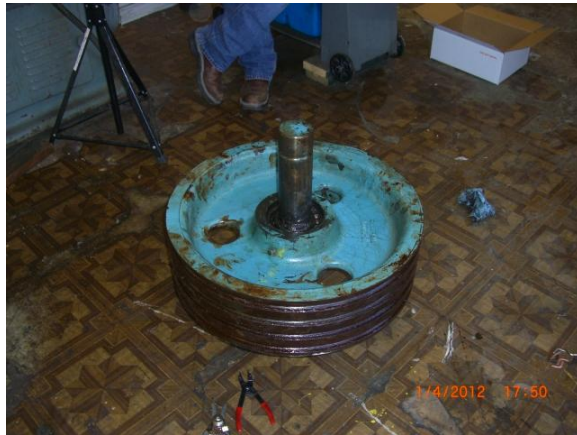
Crockett Hotel-010070
Deflector sheave ready for repairs

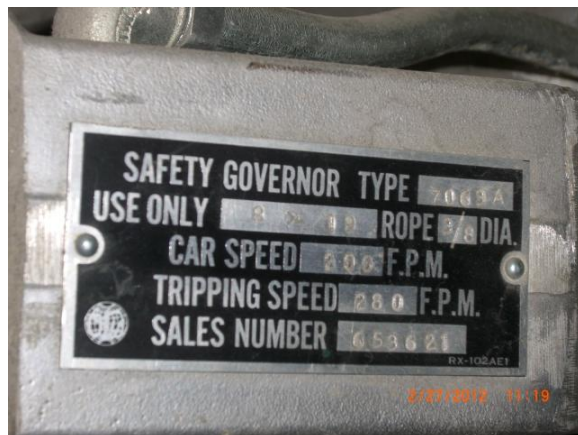
Crockett Hotel-010070

Over speed governor tag

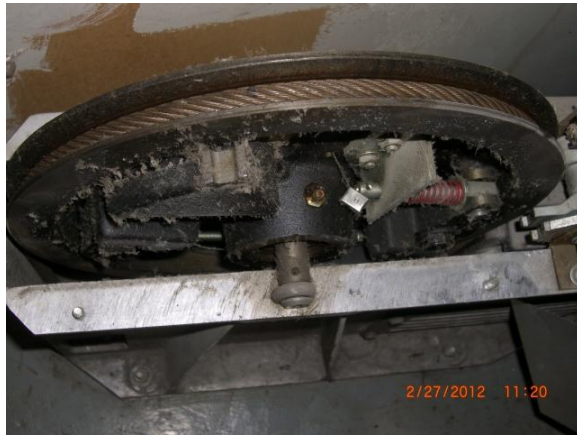
Crockett Hotel-010070

Governor without cover showing dust and lint

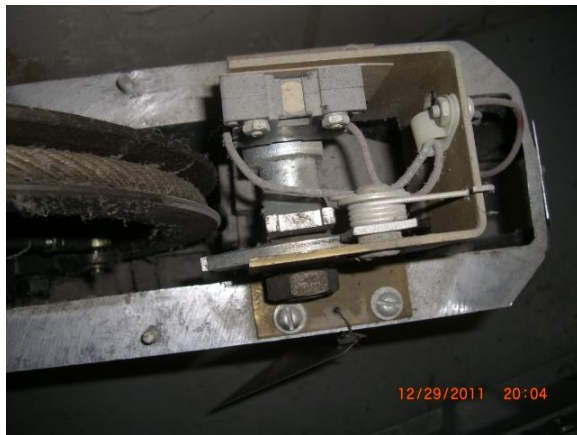
Crockett Hotel-010070

Governor switch tripped in up direction

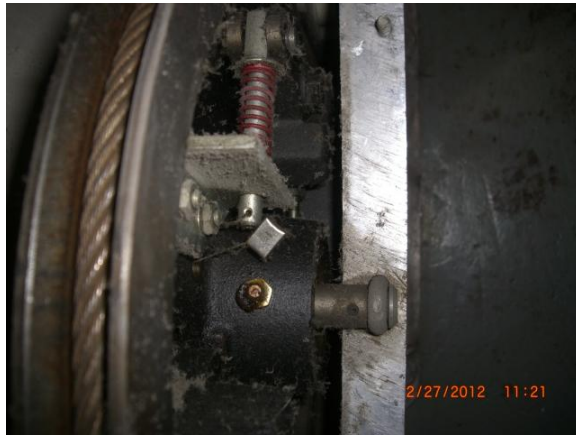
Crockett Hotel-010070
Governor seal dust and lint

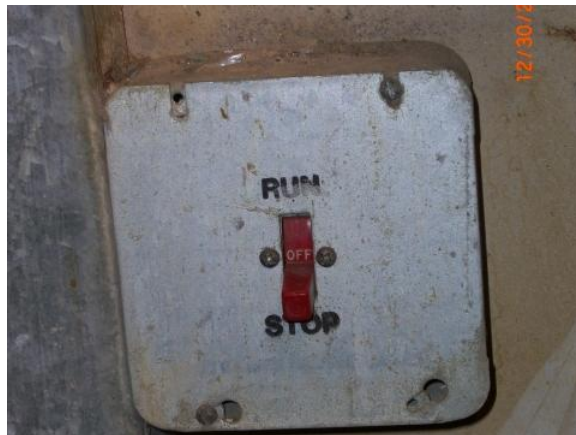
Crockett Hotel-010070
Pit stop switch in off position

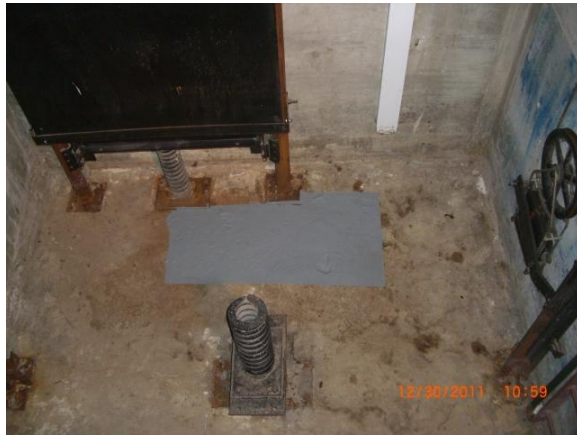
Crockett Hotel-010070
Pit area sealed after hazmat cleanup

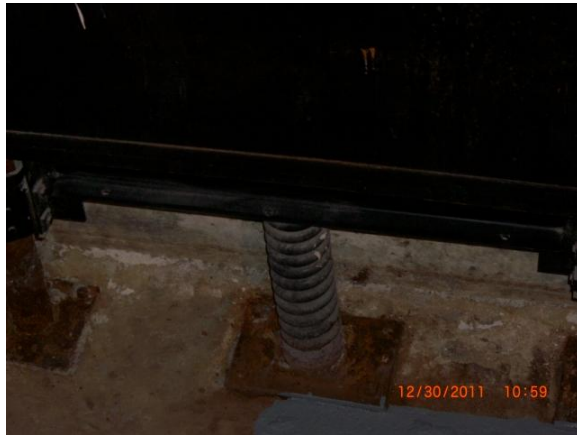
Crockett Hotel-010070

Counterweight resting on counterweight spring
buffer

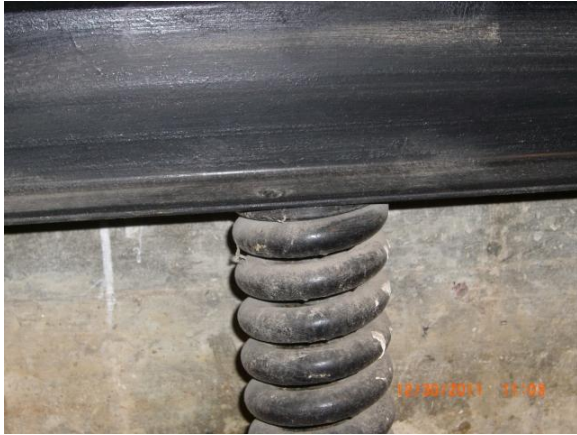
Crockett Hotel-010070
Counterweight resting on its buffer

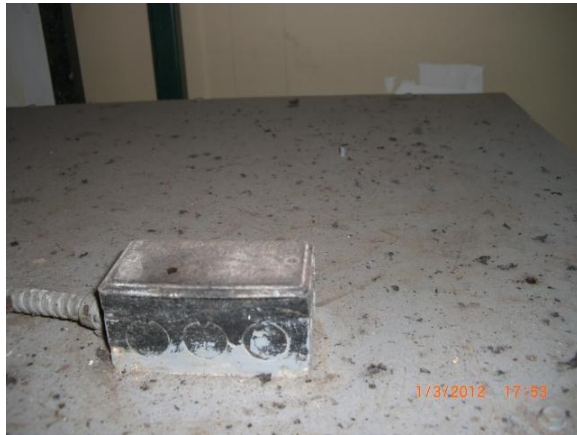
Crockett Hotel-010070

Dusty car top

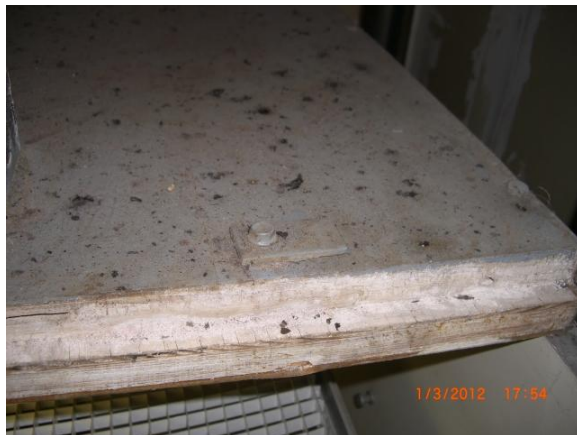
Crockett Hotel-010070

Latch on the car top exit panel left un-latched

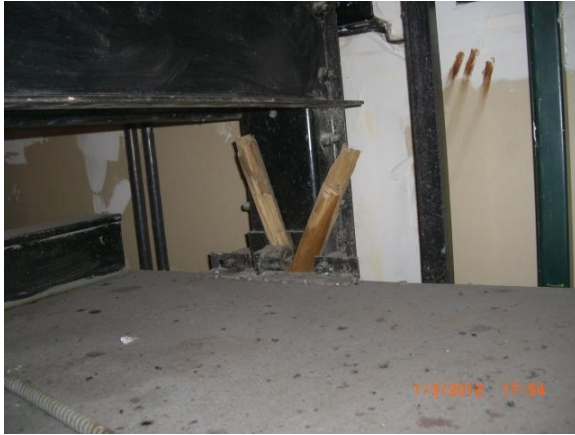
Crockett Hotel-010070

Wood substituted for car steady bracket

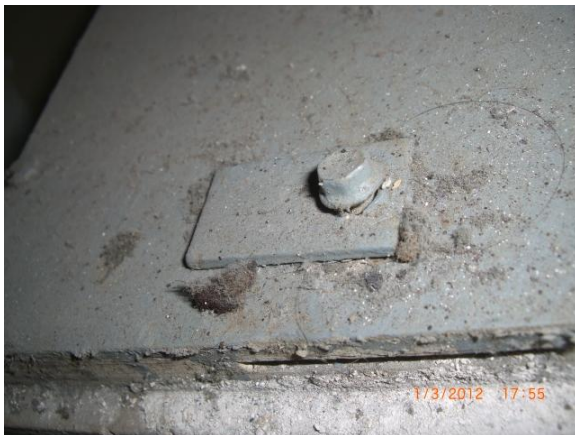
Crockett Hotel-010070

Dusty car top and car top exit panel latch left unlatched

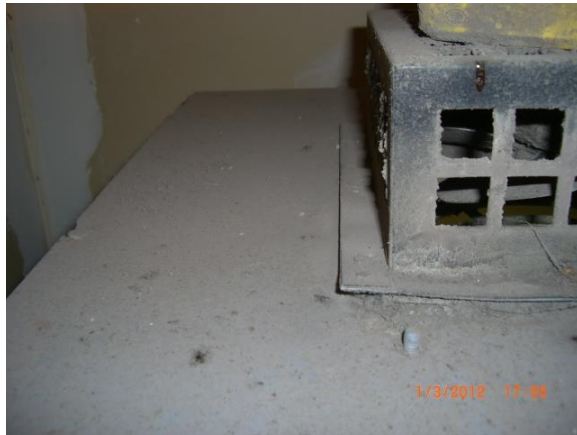
Crockett Hotel-010070

Dusty car top

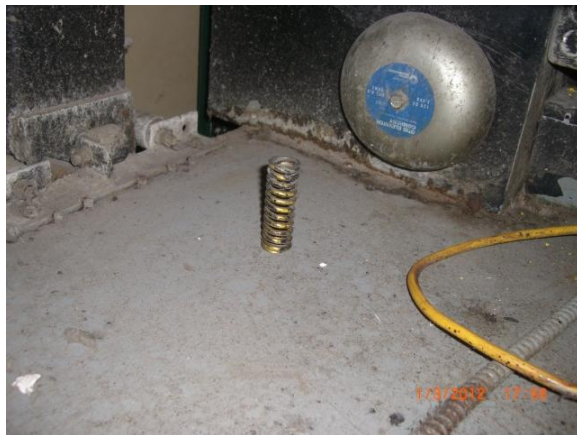
Crockett Hotel-010070

Spring of unknown origin left on the car top

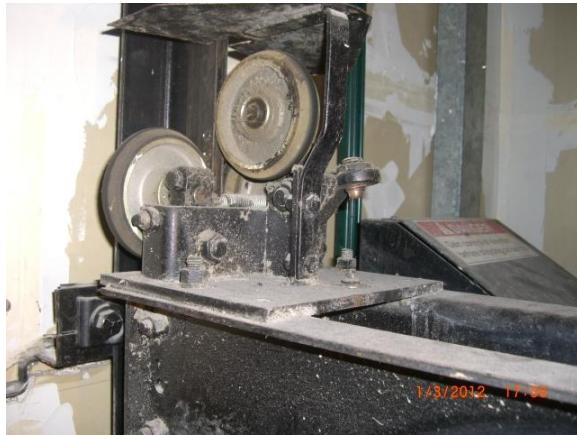
Crockett Hotel-010070

Dusty car crosshead and roller guide

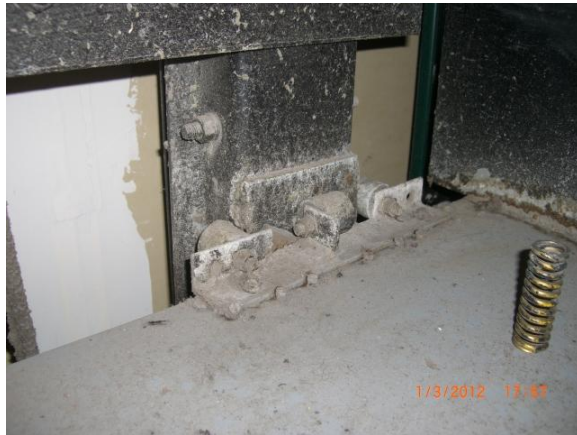
Crockett Hotel-010070

This is what the car steadying bracket should look like with a spring left on the car top

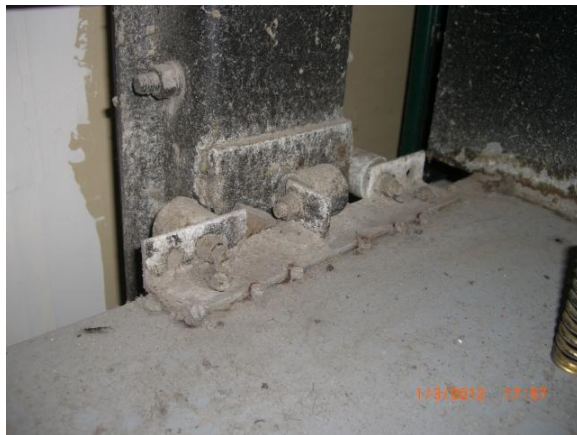
Crockett Hotel-010070

Dusty car top and steadying bracket

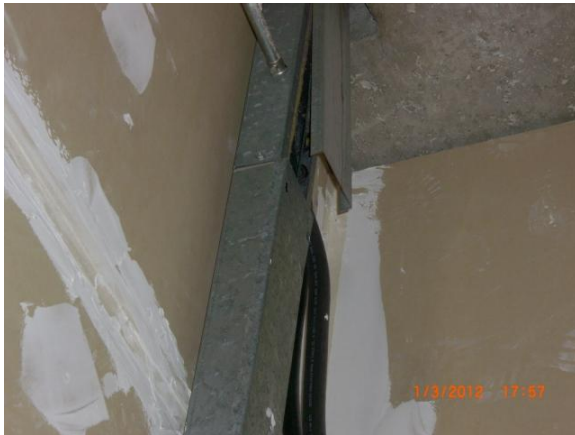
Crockett Hotel-010070

Traveling cable run under the open wiring duct cover

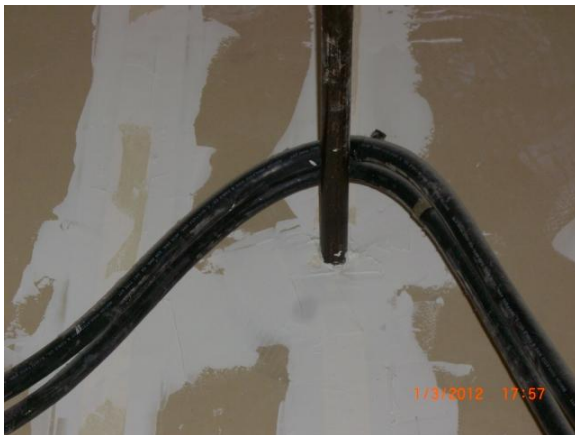
Crockett Hotel-010070

Traveling cable being supported by the sprinkler piping

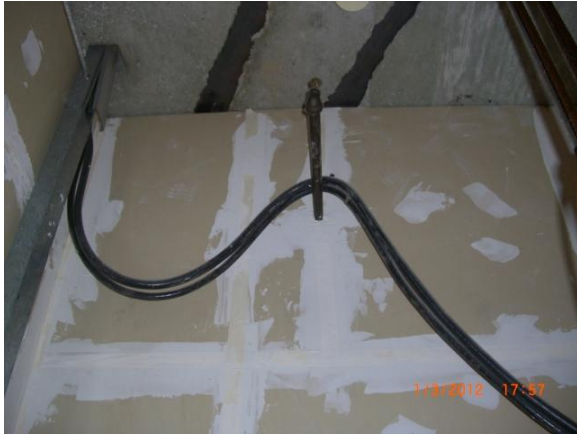
Crockett Hotel-010070

Traveling cable being supported by the sprinkler piping

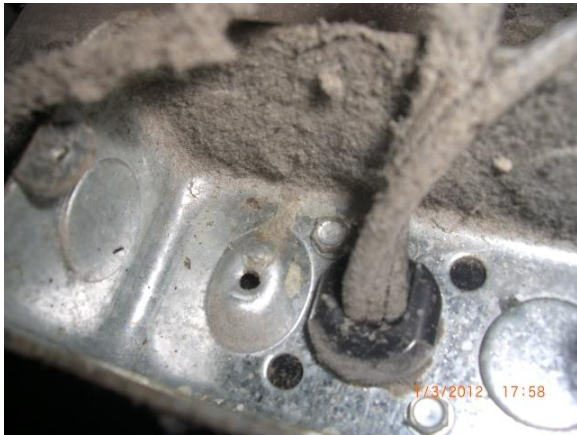
Crockett Hotel-010070

Dirty car top electrical box

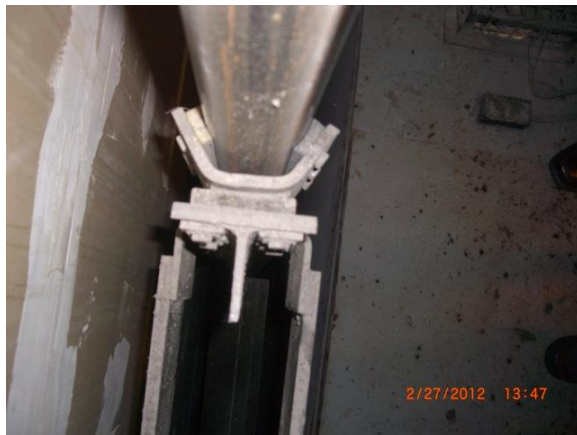
Crockett Hotel-010070

Proper engagement of the other counterweight
guide

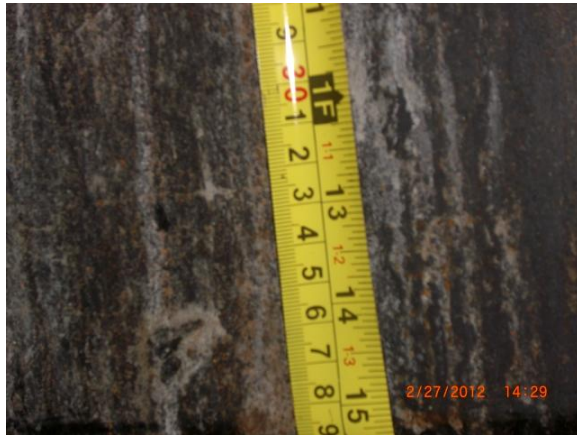
Crockett Hotel-010070

Smudge on fascia in hoistway

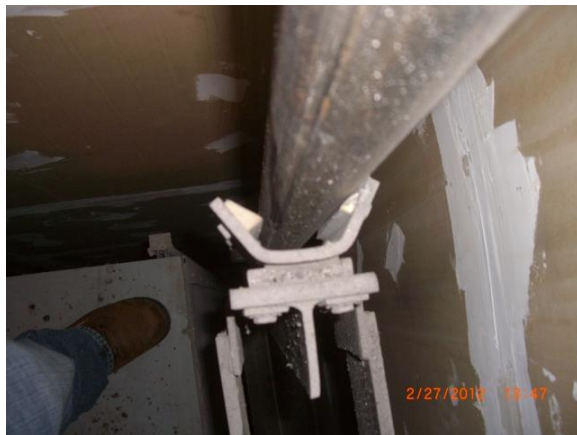
Crockett Hotel-010070

Counterweight guide nearly off the rail

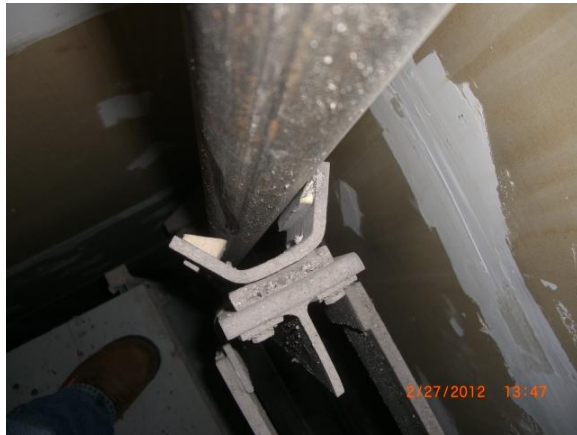
Crockett Hotel-010070
Counterweight guide nearly off the rail

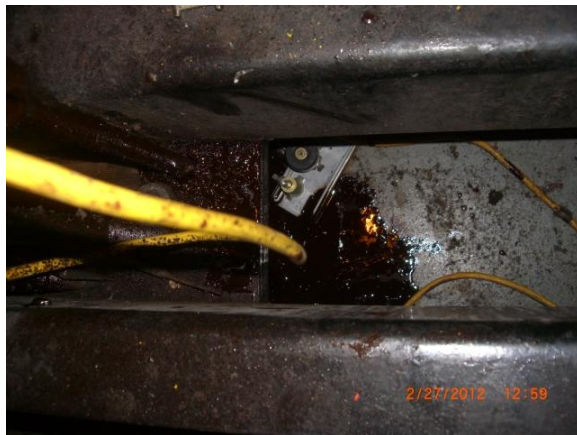
Crockett Hotel-010070
Oil and spare parts on the car top

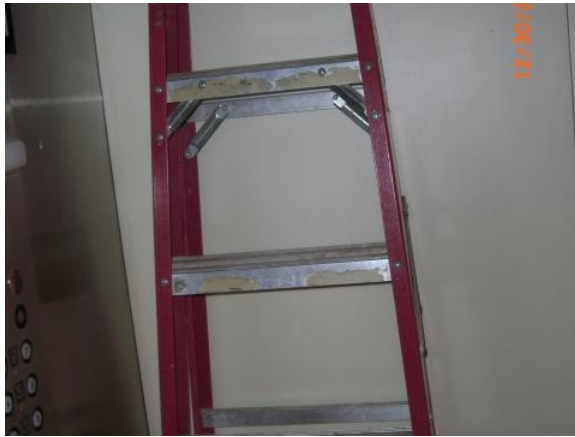
Crockett Hotel-010070

Ladder found stored in elevator car

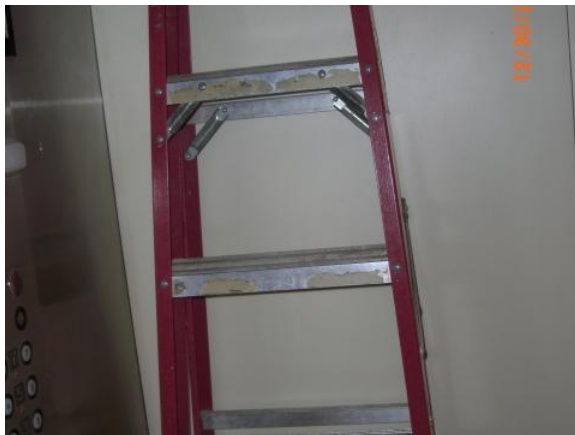
Crockett Hotel-010070

Ladder found stored in elevator car
